CRYING SHUTTERS

AL-V-A-039 Route 36, Wright's Crossing ca. 1890

INVENTORY FORM FOR STATE HISTORIC SITES SURVEY

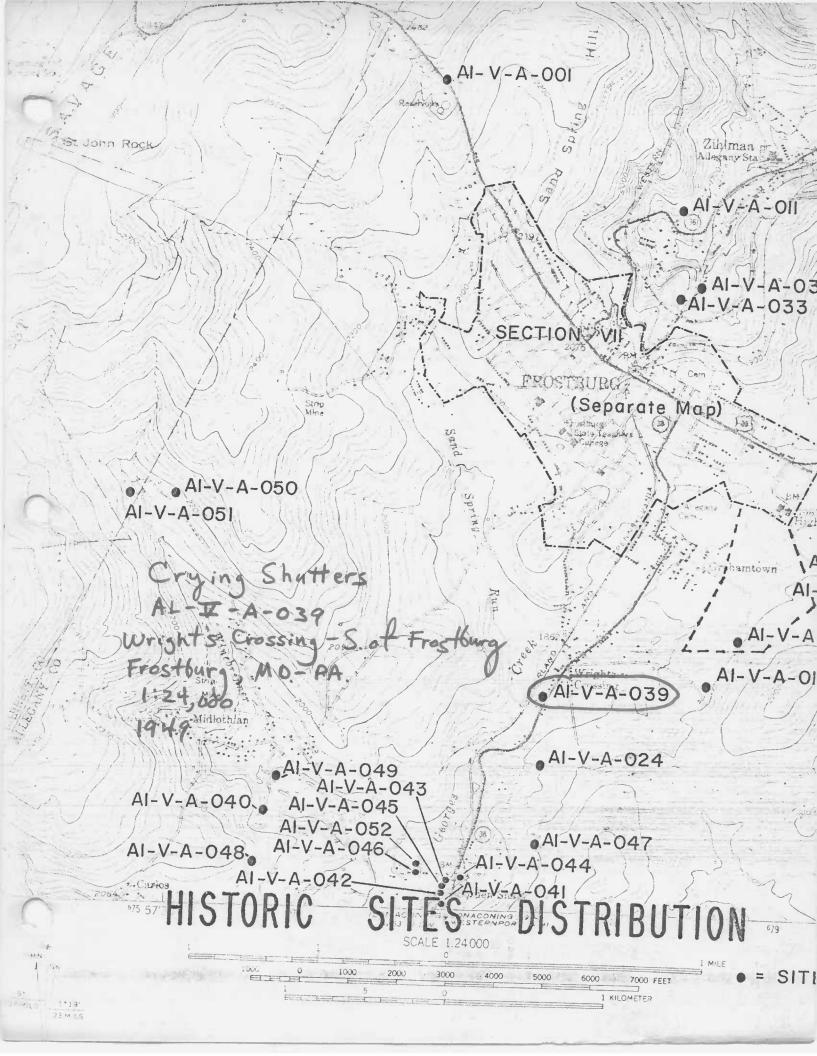
"Crying Shutters" is a two story, five bay wide, rectangular structure that has been covered with weatherboard. Two frame additions are located on the west side of the building. The entire structure rests on a low foundation that is part cement block and part stone. The roof is gabled and is covered with tin with a boxed cornice and returns. Windows in the house are a combination of two over two and four over four lights with cornices and louvered shutters. The main entrance is located in a three sided entrance hall and includes a carved door with a window. This entrance is covered by a five bay hipped roof porch that is supported by scrolled brackets and chamfered columns. A second side entrance is also covered by a one bay entrance porch. Three original corbeled brick chimneys are located in the interior of the building.

"Crying Shutters" is in fair condition and retains much of its original fabric and appearance.
